DAVID TAYLOR MODEL BASIN WASHINGTON, D. C. 20007

UNDERWAY VIBRATION SURVEY ON THE USS OKINAWA (LPH-3) — A CASE STUDY OF SUPERSTRUCTURE VIBRATION

April 1966

Report 2161 SCN 30013

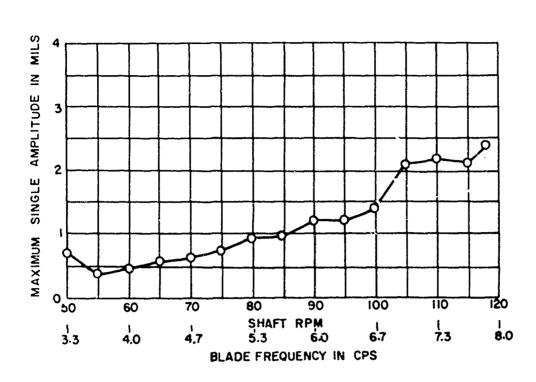
Figure 7 - Vertical Blade Rate Vibration Amplitudes on OKINAWA at Centerline of Main Deck, Frame 135, during Steady-Speed Runs versus Shaft RPM

The maximum blade frequency amplitudes of vertical and athwartship vibration measured at the fantail (Frame 135, main deck centerline) during steady-speed runs versus rpm are shown in Figures 7 and 8, respectively. The accelerations corresponding to the fantail vertical and athwartship maximum vibrations during steady-speed runs are given in Figures 9 and 10, respectively.

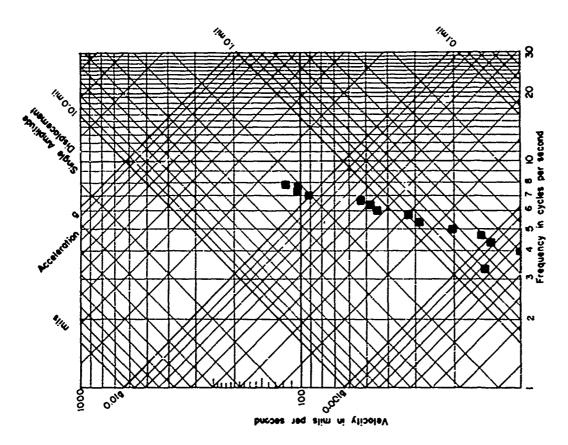
Figure 11 - Average Amplitude Components of Propeller-Excited Vertical Vibration at Fantail during Steady-Speed Runs

The average amplitudes of shaft frequency, blade frequency, and the first two harmonics of vertical and athwartship vibration at blade frequency at the fantail as determined by narrow bandwidth filtering are shown in Figures 11 and 12, respectively.

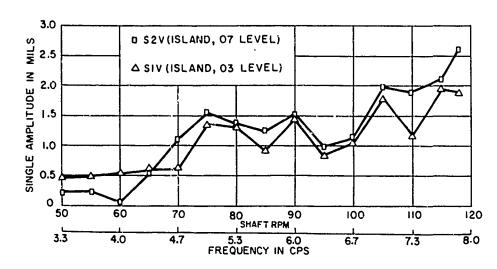
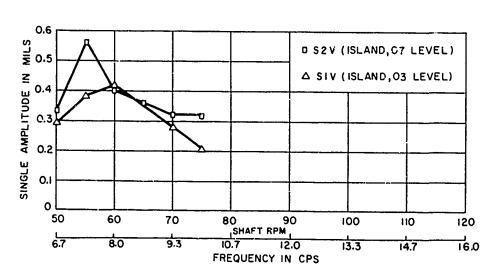
Figure 13 - Maximum Amplitudes of Vertical Vibration of the Island Structure during Steady-Speed Runs

Maximum amplitudes of blade frequency and double blade frequency vibrations of the island-radar mast structure determined from visual analysis of the oscillogram records are shown in Figures 13 through 15. The maximum amplitudes of athwartship blade frequency vibration of the island-radar mast are summarized in Figure 15a. The athwartship vibration amplitudes at the topmast (58 ft above island 07 level), at the service platform (30 ft above island 07 level), and at the top of the island (07 level) showed large amplification relative to athwartship amplitudes at the base of the island (03 level) at ship speeds above 85 rpm.

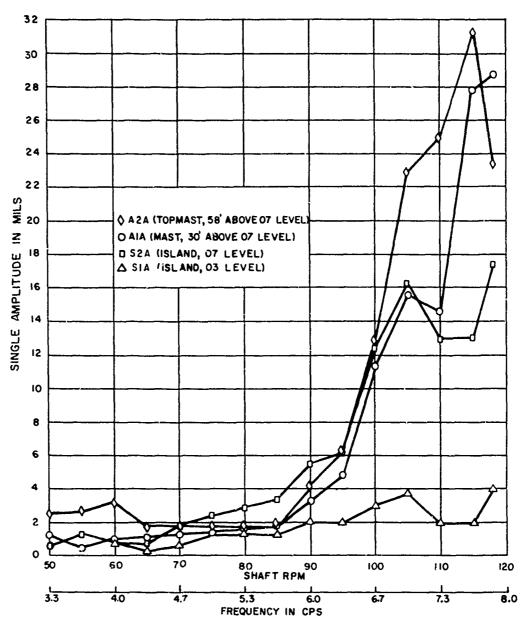
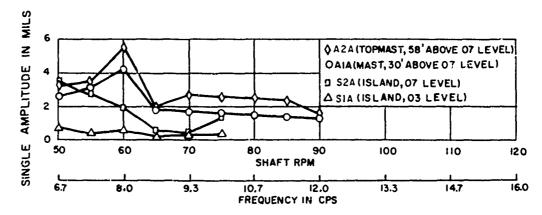
Figure 15 - Maximum Amplitudes of Athwartship Vibration of the Island-Radar Mast Structure during Steady-Speed Runs

The plot of maximum athwartship amplitudes at blade frequency versus rolligure 15a) revealed the presence of a peak athwartship vibration of the mast at 115 rpm (7.7 cps). The amplitude profile of athwartship vibration of the island-mast structure at blade frequency measured at 115 rpm is shown in Figure 16.

Athwartship vibration amplitudes at the top of the island had large amplification relative to the base of the island at speeds above 85 rpm, indicating that the island behaves as a cantilevered beam at high ship speeds. The measured data further indicated that the large athwartship island motions involved the entire island-radar mast structure. On the basis of vibration computations of this structure made by the Bureau of Ships, it was recommended that the topmast on all LPH-2 class ships be stiffened by increasing the inertia at its base and top and simultaneously reducing the plating thickness in order to approximate the weight of the original topmast.

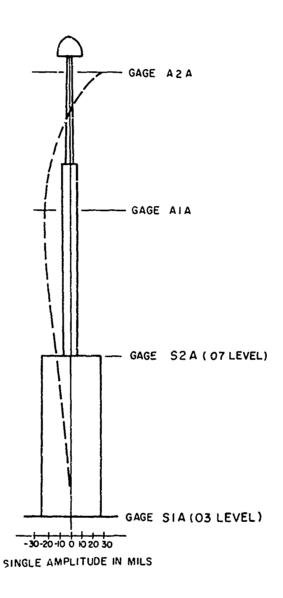
Figure 16 - Amplitude Profile of Athwartship Vibration of the Island-Mast Structure at Blade Frequency at 115 RPM

The measured amplitude profile of the blade frequency component of mast athwartship vibration at 115 rpm (Figure 16) shows that large motions occurred in the vicinity of the topmast; in particular, there was relatively large rotation at a nodal point along the topmast. Although the recommended redesign of the topmast would be expected to mitigate the vibration of the upper mast, it would not be expected to significantly change the motion of the entire island-radar mast structure; no vibration measurements on the redesigned mast structure have been made, however, to substantiate this.

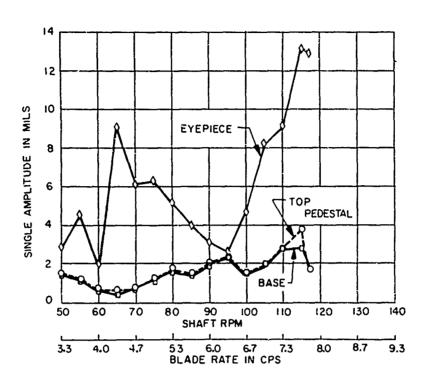
Figure 17 - Vertical Vibration Amplitudes at Blade Rate versus Shaft RPM at Mark 63 Director 2

Maximum amplitude components of propeller-blade-excited vibration measured on the Mark 63 Director 2 are given in Figures 17 through 19. The vertical vibration amplitudes at blade rate measured on the director at the base, pedestal, and eyepieces are plotted versus shaft rpm in Figure 17. The athwartship vibration amplitudes at the director base, pedestal, and eyepiece at blade rate versus shaft rpm are shown in Figure 18. The longitudinal blade rate vibrations of the director are shown in Figure 19. The blade rate amplitudes at the three locations of the director showed an increase in amplitude from the base to the eyepiece which was nearly independent of the direction measured. The measured amplitudes for the three directions and the three gage locations are listed in Table 5 for those frequencies at which considerable magnification could be observed. These frequencies should be considered as pertinent to the director.

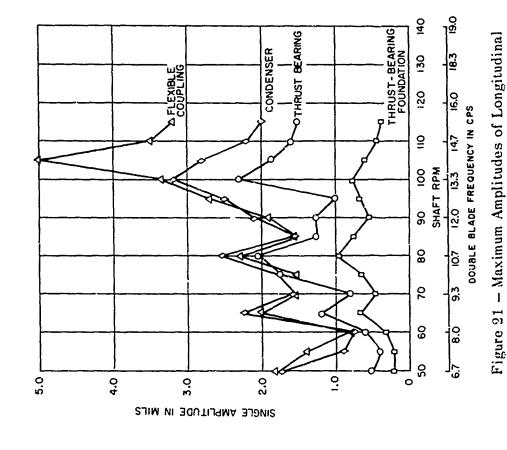
Figure 20 - Maximum Amplitudes of Longitudinal Blade Frequency Vibration of the Main Propulsion Machinery Components

The maximum longitudinal vibration amplitudes at blade rate and double blade rate measured on the main propulsion machinery are presented in Figures 20 and 21, respectively. Maximum longitudinal blade frequency amplitudes are summarized in Table 6, and calculations of shaft-machinery frequencies are given in Appendix A.

The corresponding values obtained (by Philadelphia Naval Shipyard during builder's trials in May 1962) prior to stiffening of the flexible coupling are included in Table 6 for comparison. At 65 rpm (8.7-cps double blade frequency), all four of the measured machinery components vibrated in phase. At 80 rpm (10.7 cps double blade frequency), the flexible coupling vibrated out of phase with the other machinery components. At 100 rpm (13.3-cps double blade frequency), the condenser and flexible coupling vibrated out of phase with respect to the thrust bearing and thrust-bearing foundations.

An examination of longitudinal machinery vibrations shown in Figures 20 and 21 indicate that a resonant condition of the propulsion system is being approached at maximum shaft rpm. The second-order blade frequency forces excite three distinct resonances of the main propulsion machinery. The calculated fundamental frequency for the propulsion system of 8.9 cps agrees well with the measured peak at 8.7 cps. The measured resonances at 10.7 and 13.3 cps and the relative phase of the machinery components measured at these frequencies indicate that the propulsion system is more complex than the model assumed for the calculation. This was not investigated in further detail since the vibration levels of the machinery components were not excessive and determining the structural characteristics of the machinery components for a more realistic mathematical model would have required more extensive analysis.

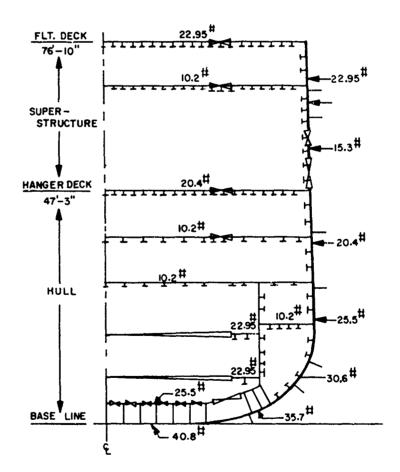
Figure 22 - Hull Cross Section of OKINAWA at Midship Showing Plating Thicknesses in Hull and Superstructure up to the Flight Deck

It should be noted that up to the main or hanger deck of OKINAWA, the midship depth of the hull is 47.2 ft whereas the depth to the flight deck is 76.8 ft. As noted from the midship hull cross section (see Figure 22), the plating thickness of the superstructure from the main deck to the flight deck is able to sustain substantial bending and shear loads. Consequently, empirical equations for estimating the fundamental vertical mode of ships with superstructures like those of the LPH-2 class should include the inertia of the superstructure frem the main deck to flight deck in addition to the hull inertia and/or should consider the effective depth to be greater than the depth to the main deck. It cannot be concluded with certainty whether the depth up to the flight deck should be used to yield a more accurate prediction of the fundamental vertical frequency from empirical equations (some percentage of this depth would probably be more realistic). It is, however, important that some allowance be made for the dynamic influence of the superstructures on the hull vibrations for ships with superstructure geometry similar to the LPH-2 class.

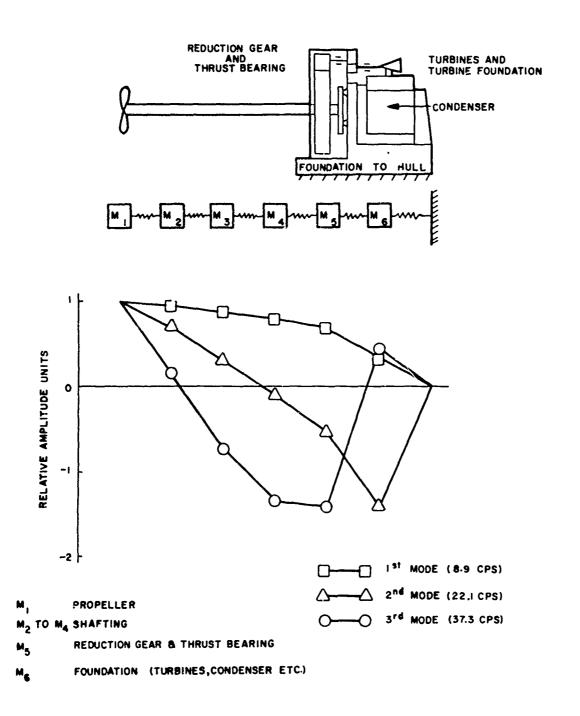
Figure 23 - Mechanical Model and Relative Mode Shapes for Longitudinal Vibrations of OKINAWA Propulsion System

Calculations of longitudinal shaft vibrations including the influence of the propeller and machinery components were performed on an electric analog computer to help interpret the measured results. The mechanical system assumed for the longitudinal shaft vibration calculations is shown in Figure 23. It consists of six discrete masses and springs connected in series representing the propeller-shaft-machinery system. Figure 23 also shows the calculated mode shapes for the first three natural frequencies which were found to be 8.9, 22.1, and 37.3 cps, respectively.

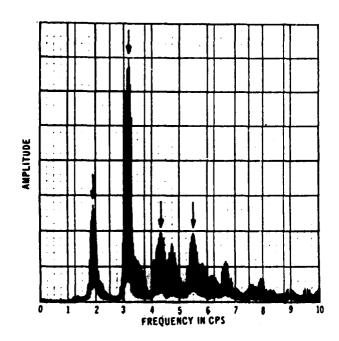
Figure 24 - Amplitude-Frequency Spectrum of Hull Vertical Vibration of OKINAWA Recorded by Gage H8V (Frame 13, Main Deck Centerline) during Anchor Drop Test

5.8 cps; higher modes were uncertain. Ratios of the higher vertical hull modes to the fundamental vertical mode follow the series 1, 1.6, 2.2, 2.8, etc., as contrasted with the series 1, 2, 3, etc. found on a number of surface ships. A possible explanation for the latter result may be found in the superstructure geometry of OKINAWA, which is characterized by a lack of shear continuity over the length of the hull above the hanger deck.

Arrows indicate huli vertical natural frequencies.

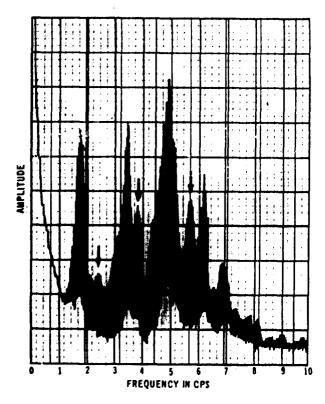
Figure 25 - Amplitude-Frequency Spectrum of Hull Athwartship Vibration of OKINAWA Recorded by Gage H9A (Frame 13, Main Deck Centerline) during Anchor Drop Test

Arrows indicate hull athwartship natural frequencies.
